AFRL-ML-TY-TR-2004-4548

**Performance Effectiveness Testing of the
Expeditionary Fire Suppression System; Phase II**

**Kimberly D. Barrett
Jennifer L. Kalberer
Applied Research Associates
PO Box 40128
Tyndall AFB, FL 32403**

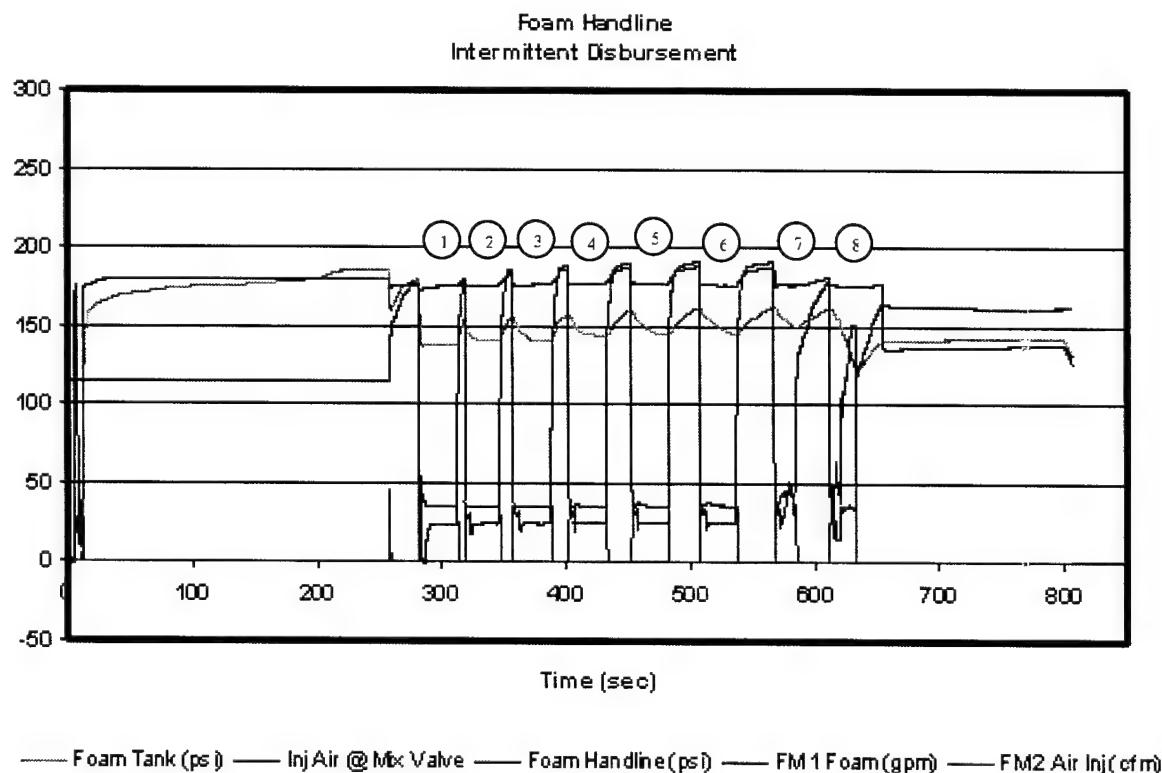
Figure 2. Handline Foam Flow and Pressure Data, Intermittent Disbursement.

Figure 2 shows the pressures and flow rates prior to the change of regulators. The foam tank pressure, during flow and non-flow periods increased over the duration of the test. During flow periods the foam tank pressure was approximately 30-40 psi below the set pressure of the regulator (138 psi, phase 1, to 151 psi, phase 5). The injection air pressure prior to flow was 180 psi, although it was set before the test to 190 psi. The injection air stayed relatively constant during flow periods, between 175 and 178 psi. The pressure at the handline functioned normally at 25 psi during flow periods and 175 psi during non-flow periods. The foam flow rate was approximately 35 gpm for each phase. No injection airflow was recorded for this test. The injection air flow meter was tested and a visual inspection at the nozzle was performed. This indicated a flow less than 2.5 cfm, which was the low-end of the flow meter and confirmed that the flow meter was working correctly and little air was coming out of the nozzle.

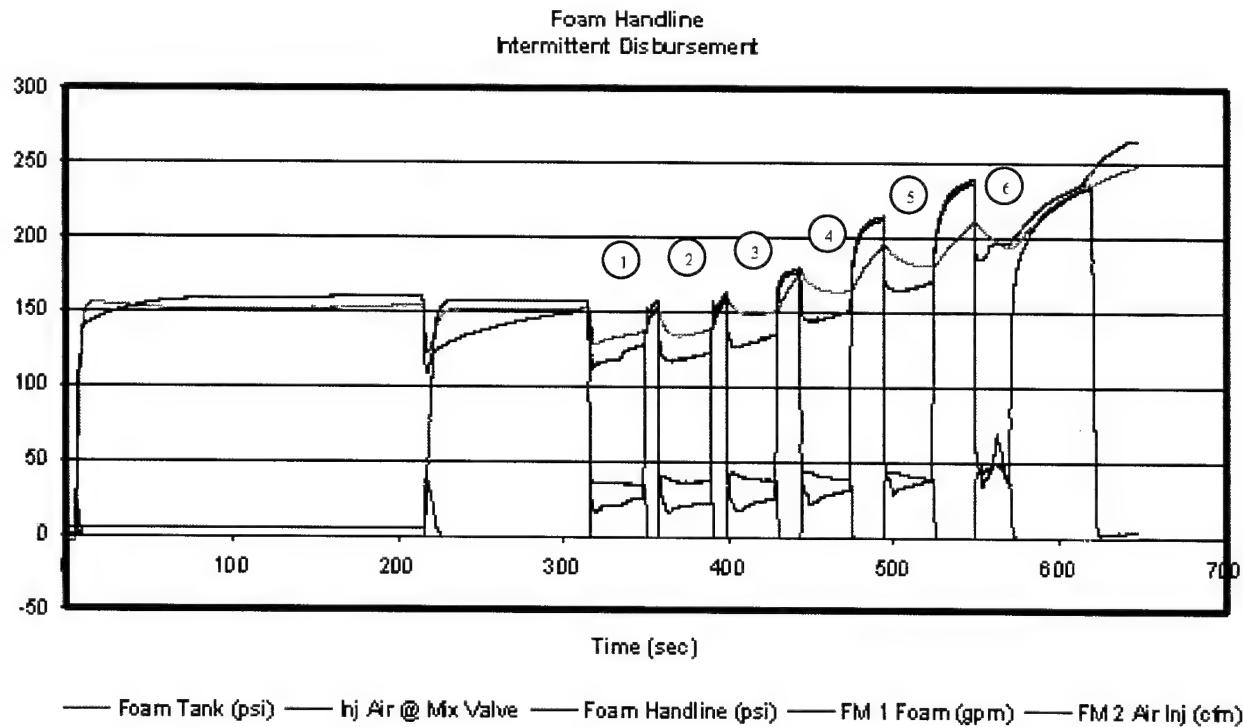
Figure 3. Handline Foam Flow and Pressure Data, Intermittent Disbursement.

After the regulators were changed problems continued with the regulation of pressures and the system charging slowly. Also, new problems developed, such as pressure build-up and sudden pressure loss at the foam air tank developed during flow. The same manufacturer settings were kept after the new regulators were installed (foam at 185 psi, injection air at 195 psi). Figure 3 shows the pressures and flow rates after the regulators were changed. Prior to this test, neither the foam tank nor the injection air pressures were reset. When testing began, the foam tank and injection air pressures were 154 and 160 psi respectively. The foam tank pressure during flow periods increased over each phase with a beginning pressure of 129 psi and an ending pressure of 194 psi. The pressure of the foam tank during non-flow periods increased from 151 psi, phase 1, to 250 psi, phase 6. The injection air pressure during flow increased from 114 psi, phase 1, to 188 psi, phase 6. The pressure during non-flow periods also increased substantially from approximately 149 psi, phase 1, to 265 psi, phase 6. During phase 6 the pop-off valve blew on the foam tank. The foam handline pressure continued to rise during each phase of the test between 18 to 66 psi. During non-flow periods the pressure climbed from 157 psi, phase 1, to 233 psi, phase 6. This indicated that the foam and injection air regulators were not functioning correctly. The flow meter showed a steady increase in the flow rate as the pressure in the tank and injection air increased. The gpm increased from an average of 36 gpm, phase 1, to an average of 42 gpm, phase 5. No injection air data was recorded during this test. The pop-off valve (set to 250 psi) blew when the foam tank and injection air pressures reached 249 and 264 psi, respectively.

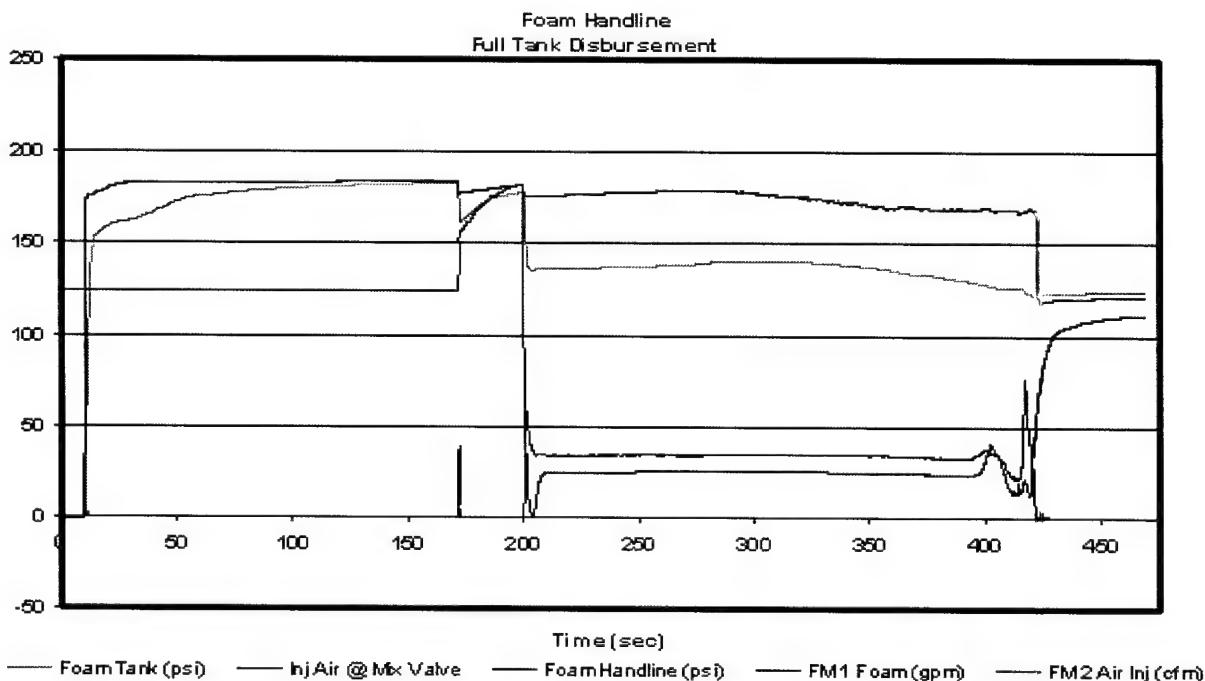
Figure 4. Handline Foam Flow and Pressure Data, Full Tank Disbursement.

The pressures and flow rates prior to the change of regulators are shown in Figure 4. When the foam was discharged, the foam tank pressure decreased to 176 psi and the injection air pressure decreased to 136 psi. The pressure in the foam tank showed a slight decline in pressure toward the end of the test. For this test, the regulator was functioning normally and maintaining pressure close to the set point. The pressures at the end of the test for the foam tank and injection air were 169 and 129 psi. The handline pressure was maintained at an average pressure of 24 psi. The foam flow was maintained at approximately 34 gpm throughout the test. No injection airflow was measured.

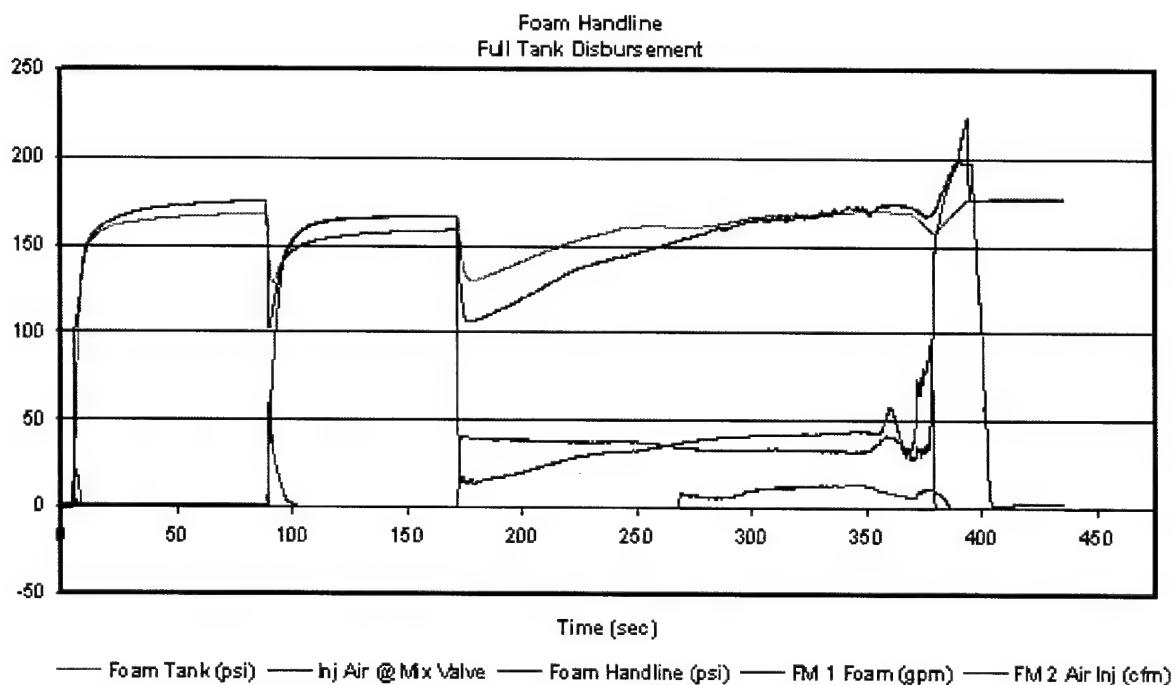
Figure 5. Handline Foam Flow and Pressure Data, Full Tank Disbursement.

Figure 5 shows the pressures and flow rates after the regulators were changed. The foam tank pressure was 168 psi. When the test began the foam tank pressure dropped to 130 psi, continued to climb to 161 psi, stabilized for a period of approximately 20 seconds, then climb until the end of the test to approximately 170 psi. The injection air pressure fell to 106 psi when the test began but steadily climb throughout the test and at the end of the test the injection air pressure was 174 psi. The foam flow rate decreased from 41 gpm to 33 gpm over the test duration. The injection airflow started around 6 cfm and increased to 12 cfm, however, toward the end of the test the cfm dropped again to approximately 7 cfm. The injection air became readable when the injection air pressure was within approximately 8 psi of the foam tank press.

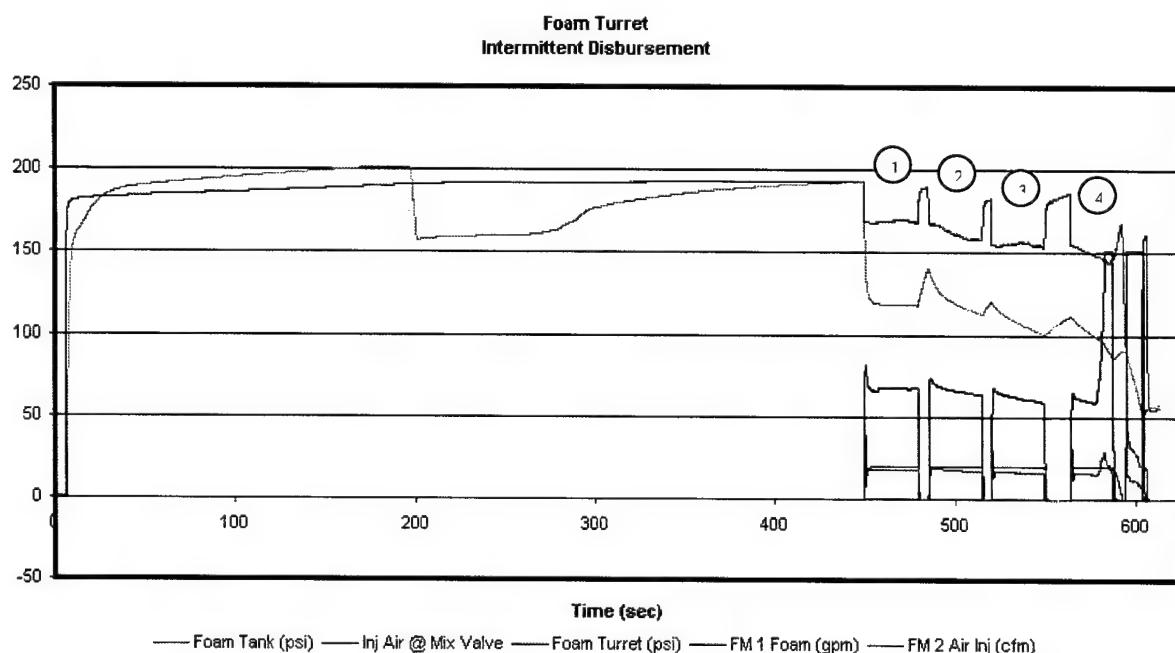
Figure 6. Turret Foam Flow and Pressure Data, Intermittent Disbursement.

Figure 6 shows the pressures and flow rates prior to the change of regulators. The foam tank regulator was adjusted from 200 psi to 185 psi per the manufacturer, however, over a period of 100 seconds the pressure increased to 193 psi. This indicated that the regulator on the foam tank was not working properly. When the test began the tank pressure steadily decreased from 118 psi, phase 1, to 89 psi, phase 4. The pressure at turret stayed relatively constant at 14 psi for the duration of testing. The foam flow showed only a decrease of 5 gpm from 67.4 to 62 gpm over the full discharge. The injection air flow averaged 20 cfm.

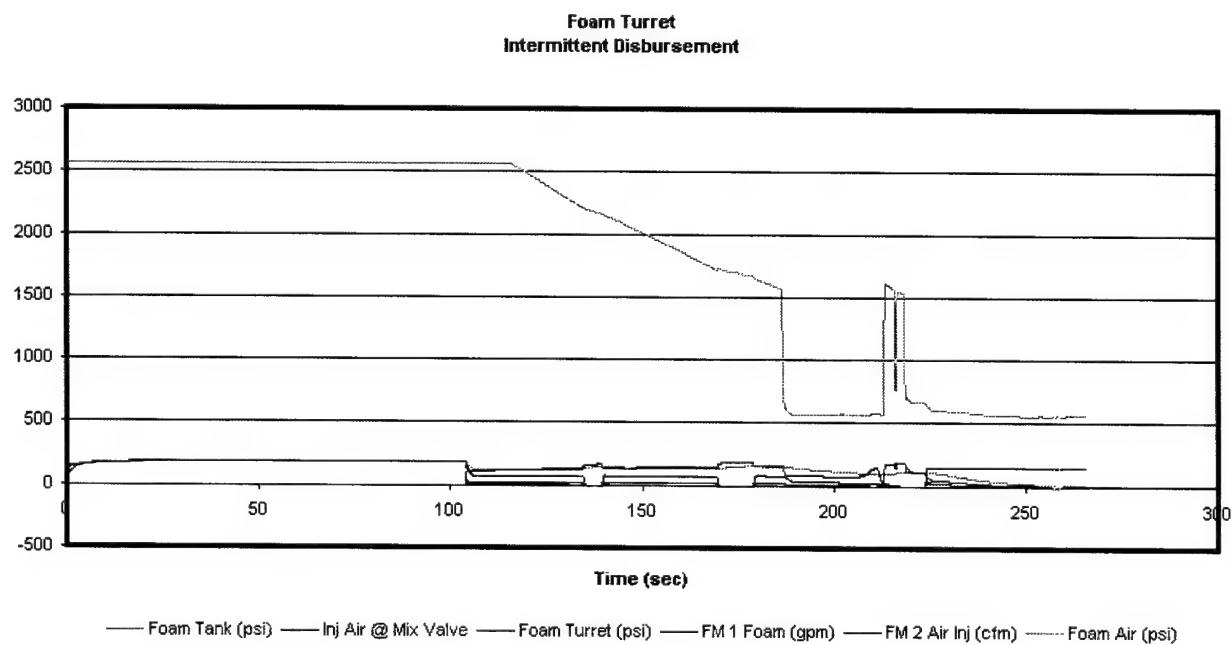
Figure 7. Foam Air Pressure Data, Intermittent Disbursement.

Figure 7 shows the pressures at the foam air tank after the regulators were changed. A drop in foam high pressure air tank occurred toward the end of the test. Problems with instrumentation would have caused a negative reading and therefore, was ruled out as the source. The exact cause of the drop in pressure was never determined and continued to occur with both foam and dry chemical testing. Prior to the drop the injection air pressure had increased from 140, phase 1, to 160 psi, phase 3 (Figure 8). The pressure at the turret during flow remained stable at 16-18 psi. The foam flow meter registered a flow rate of 70 gpm, phase 1, to 85 gpm, phase 3. The injection air flow meter stayed relatively constant at 18 cfm.

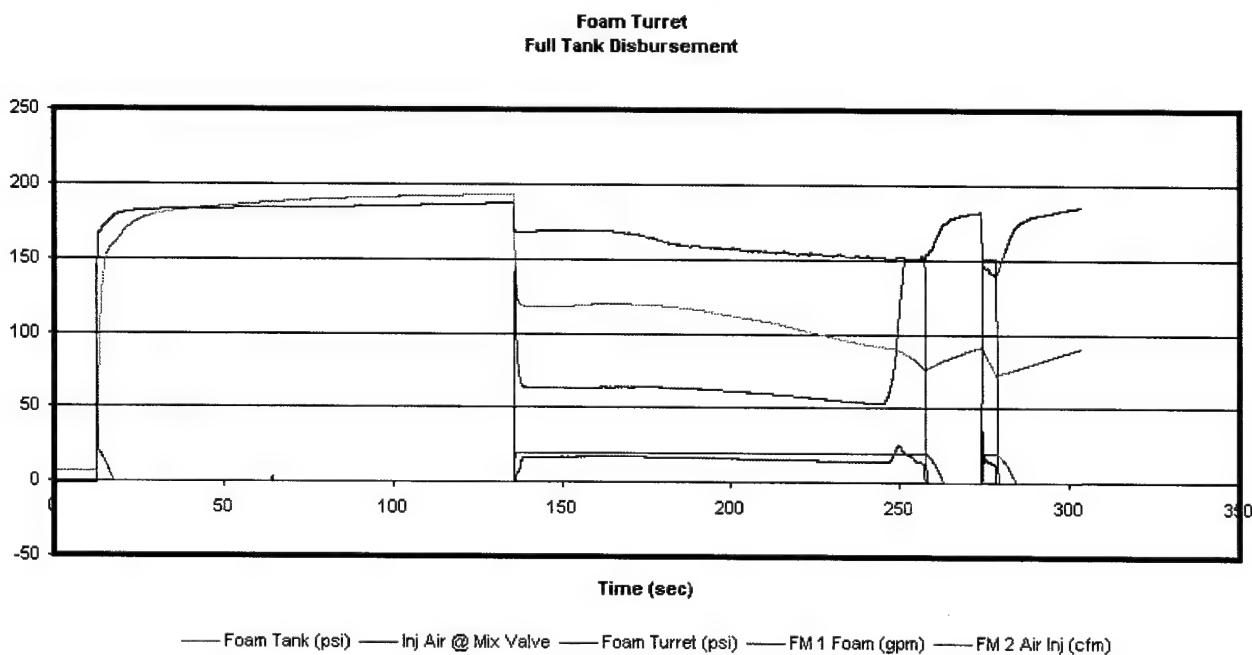
Figure 9. Turret Foam Flow and Pressure Data, Full Tank Disbursement.

Figure 9 shows the pressures and flow rates prior to the change of regulators. The foam tank pressure dropped from 190 psi to 118 psi during the full tank discharge. The pressure in the foam tank was not maintained and a steady decrease was observed for the full discharge. This suggests that a restriction exists in the system. The most likely source was the regulators since several other problems were experienced with that component, however, this was not confirmed by AFRL. The injection air pressure dropped from 186 to 152 psi. The foam flow during the first 27 seconds was approximately 64 gpm and steadily decreased to 53 gpm at the end of the test. The injection air stayed constant at 19 cfm. The pressure at the turret was consistent at 15-17 psi.

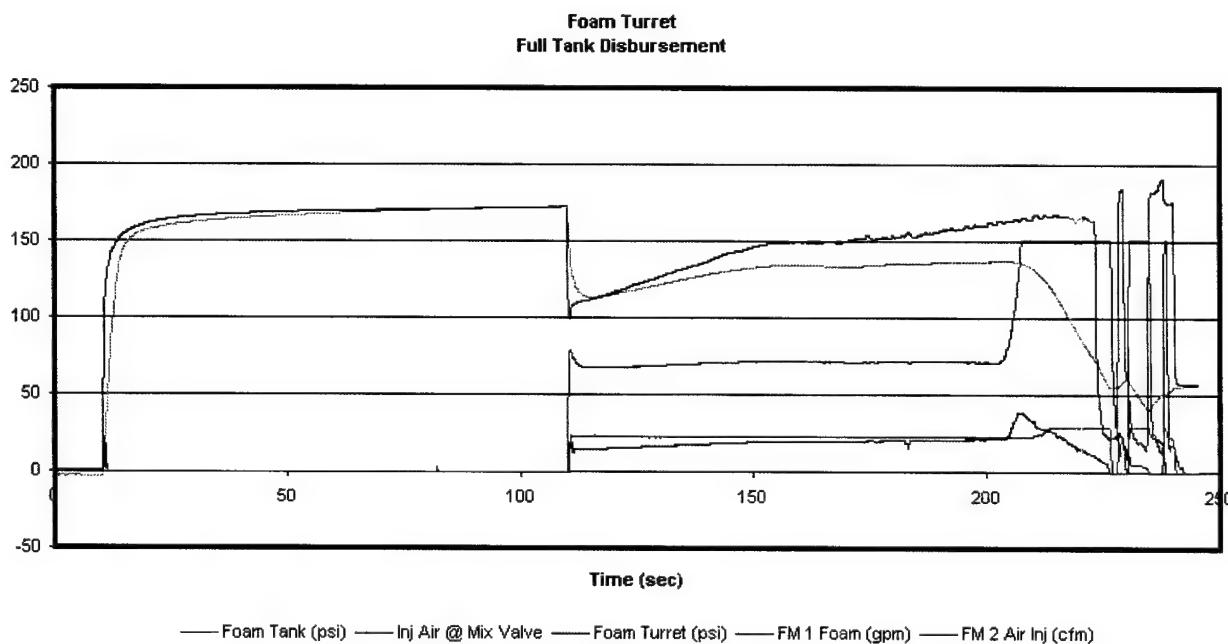
Figure 10. Turret Foam Flow and Pressure Data, Full Tank Disbursement.

Figure 10 shows the pressure and flow after the regulators were changed. Even though the new regulators were set to the manufacturer's specified settings, the foam tank pressure and the air injection pressure never reached the set points. The foam tank pressure reached 172 psi, decreased to 114 psi as the agent flowed then increased to 137 psi at the end. The injection air pressure increased to 167 psi after the initial drop of 106 psi. The foam flow was stable at 71 gpm, while the injection air meter maintained an approximate 23 cfm flow. The spike in the foam flow rate observed after the agent was depleted was likely due to the injection air that was still discharging, causing a faulty measurement. The turret pressure showed an increase from 12 to 19 psi. The injection air pressure continued to climb slightly even after the agent was depleted.

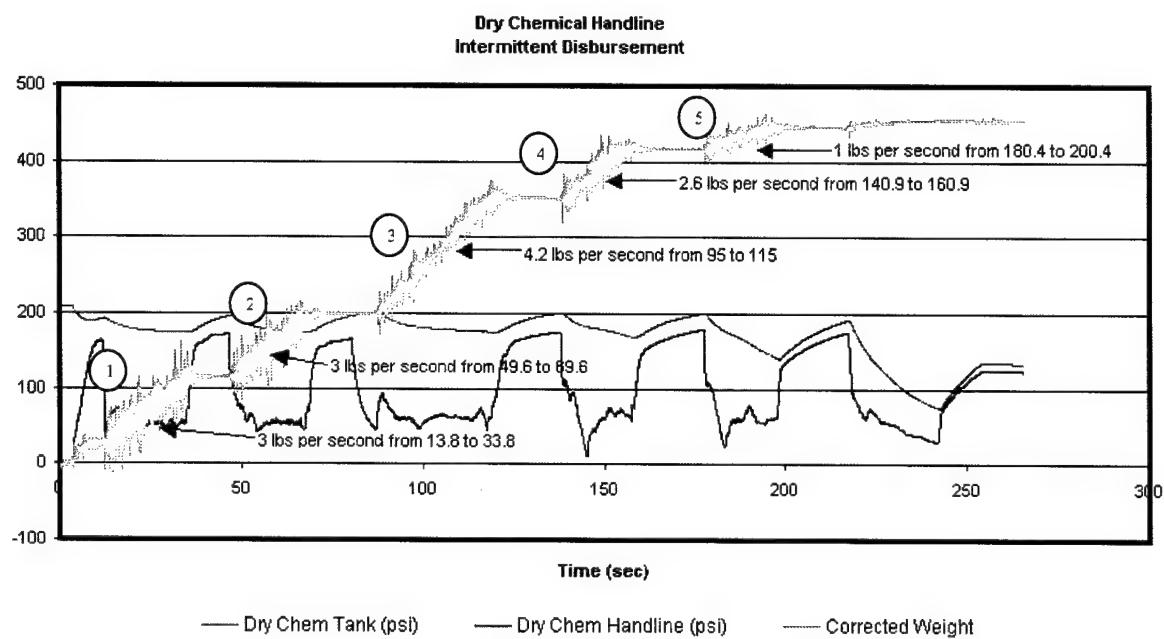
Figure 11. Handline Dry Chemical Flow and Pressure Data, Intermittent Disbursement

Figure 11 shows the pressures and flow rates prior to the change of regulators. The dry chemical tank pressure prior to the opening of the handline was approximately 209 psi. Five phases were completed during this test. The pounds per second used for each phase of the test averaged 3, 3, 4.2, 2.6 and 1. When the handline was charged, the pressure dropped to 189 psi and quickly climbed (time 5 seconds) to 192 psi. For the first three phases of flow testing, the dry chemical tank pressure remained at 175 psi. During the last two phases, the pressure dropped to 169 and 143 psi respectively. During non-flow periods the pressure remained between 191-201 psi. During the first two flow periods the handline pressure was approximately 54 psi, however, as the flow rate decreased the pressure on the handline increased to 60-70 psi.

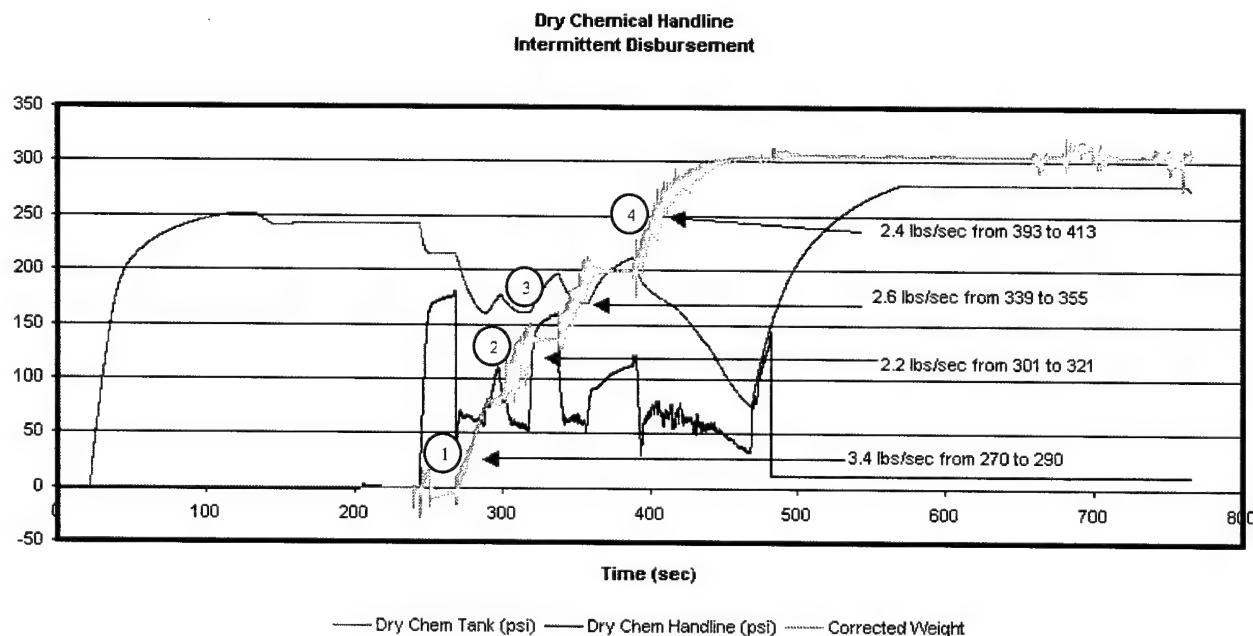
Figure 12. Handline Dry Chemical Flow and Pressure Data, Intermittent Disbursement.

Figure 12 shows the pressures and flow rates after the regulators were changed. During the four test phases, the dry chemical flow rate was more consistent and averaged 3.4, 2.2, 2.6 and 2.4. The dry chemical tank pressure exceeded the 225 psi set point during the test and had to be manually corrected prior to the next test. The pressure dropped from 242 to 214 psi when the handline was charged and remained at this pressure until the test began. During the flow period the dry chemical tank pressures were 161, 164, 170, and 77 psi and during non-flow periods the pressures were 174, 196, 211 and 278 psi. When the dry chemical tank pressure reached 278 psi the system was cut off. Figure 13 shows the foam and the dry chemical air tank pressures during this test. The foam air tank continued to lose pressure throughout the test, while at the beginning of the test the dry chemical air tank increased slightly. During the test, the foam air tank was also decreasing in pressure and after the test had ended the foam air tank continued to lose pressure, which indicated that the foam air tank was still feeding the dry chemical tank. Again, the foam and dry chemical systems are independent of one another according to the manufacturer although they behave as though they are connected. The handline pressure, when the handline was charged was approximately 177 psi and varied during agent flow. During phase 1 the flow pressure fell from 67 to 58 psi; phase 2, 58 to 53 psi; phase 3, 61 to 57 psi; and phase 4, 70 to 34 psi. The non-flow periods the handline pressure was 107, 157, 91 to 114, and 138 psi.

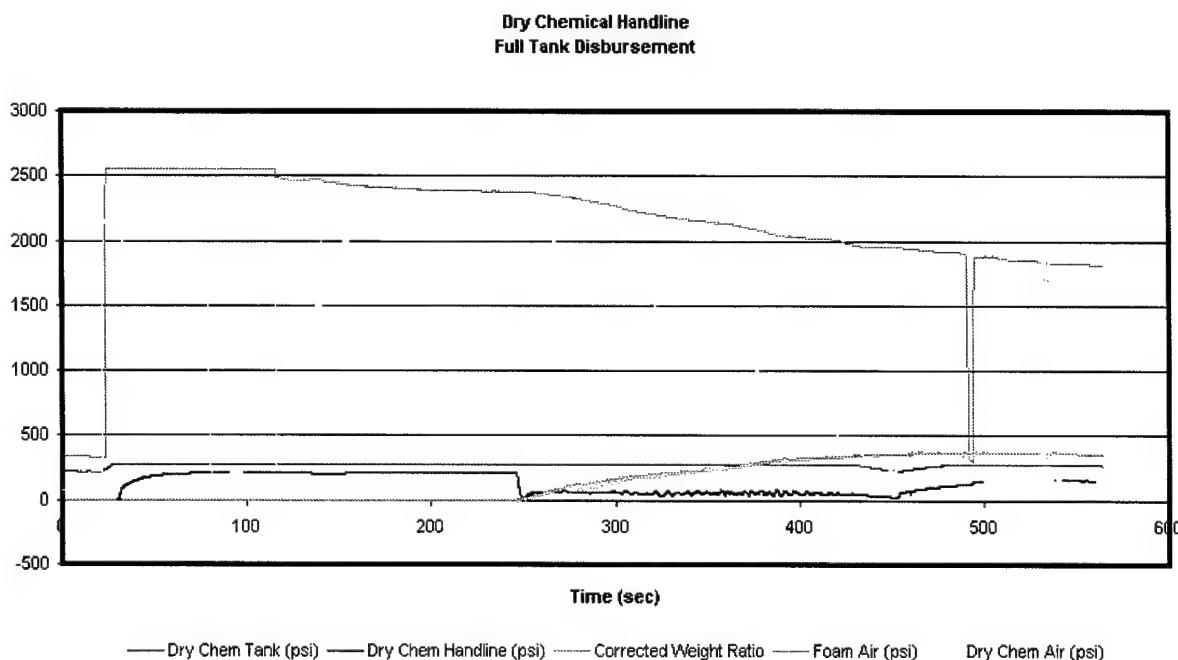
Figure 14. Air Tank Pressure Data, Full Tank Disbursement.

No dry chemical handline, full tank disbursement tests were conducted prior to the change of regulators. Figure 14 shows the air tank pressures for the foam air tank and the dry chemical air tank with the new regulators. Two drops in air pressure on the dry chemical air tank occurred during testing. One while the handline was charged, the other during agent flow. Flow and pressure measurements shown in Figure 15 do not indicate any change in the performance. Note that, as seen in the previous test, the foam air pressure continued to decrease throughout the test, while the dry chemical air increased slightly at the beginning. This indicated that the air from the foam air tank (higher pressure) was bleeding into the dry chemical air tank (lower pressure). The dry chemical tank pressure remained constant at 278 psi throughout the test even though the regulator was set at 225 psi. This constant pressure was not seen in any other test performed. The pressure on the handline nozzle was approximately 213 psi prior to the beginning of the test. When the test began, the average pressure on the handline was approximately 59 psi. The approximate discharge of dry chemical was three pps.

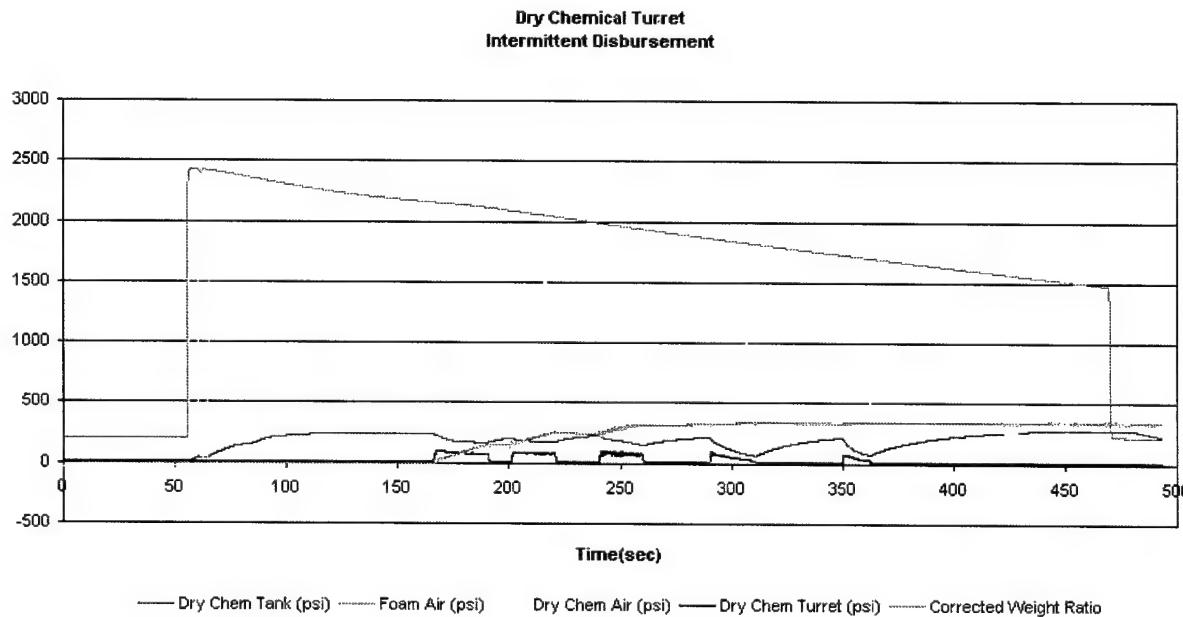
Figure 16. Air Tank Pressure Data, Intermittent Disbursement.

No tests were completed on the dry chemical turret prior to the change of the regulators. Figure 16 shows another unexplained pressure drop at the dry chemical air tank when the system was charged. The foam air tank showed a constant decline in pressure over the testing period. The dry chemical air tank showed a sharp drop in pressure after the system was charged. The dry chemical air tank pressure continued to drop until the dry chemical tank pressure (Figure 17) reached approximately 221 psi. At that point, the dry chemical air tank pressure started to increase until the agent was flowed. During each phase of the test the dry chemical air tank pressure continued to drop. The dry chemical tank pressure, once charged, increased to 238 psi. When the test began, the dry chemical tank pressure dropped to 171, 176, 152, 66 and 76 psi. The dry chemical tank pressures during non-flow periods were 198, 222, 212, 211 and 278 psi. The system was turned off at this point to prevent over pressurizing the system. The foam tank pressure during this test was 240 psi even though no foam was flowed. The turret pressures during phase 1, decreased from 97 psi to 73 psi and during phase 4 the pressure dropped from 93 to 20 psi. The dry chemical flow rate averaged 5.2, 4.5, 3.1, 0.6 and 0.5 pps. Little dry chemical was being disbursed after the third phase of the test even though only 262 lbs out of 500 lbs had been discharged. AFRL could not find an explanation for this result.

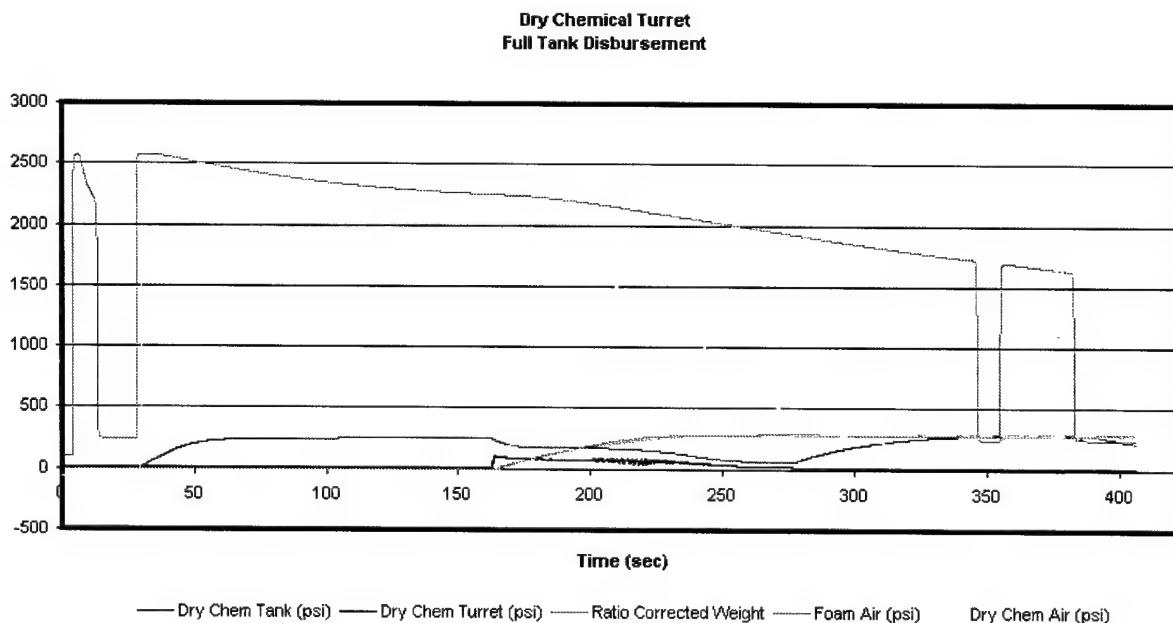
Figure 18. Air Tank Pressure Data, Full Tank Disbursement.

Figure 18 showed a drop in foam air tank pressure at both the beginning and end of the testing period. Over the testing period, the foam air tank pressure continued to drop. As with the previous testing, the dry chemical air tank pressure decreased until the dry chemical tank reached 235 psi, then increased in pressure until the test began. The foam tank pressure was maintained at 250 psi until the end of the test when the pressure increased to 261 psi (Figure 19). The dry chemical tank pressure reached 250 psi prior to the beginning of the test. The foam turret pressure decreased from 101 psi to 20 psi over the test period. The dry chemical used was approximately 4.9 lbs/sec (average from 172 to 202 seconds) for a total of approximately 147 lbs of the 500 lbs available. The majority of the dry chemical was not discharged before the pressure in the air tank was depleted. This significantly reduced the application time of the agent from 100 seconds (estimated) to 30 seconds (actual).

The volume of compressed air needed to drive the dry chemical turret operation needs to be recalculated.

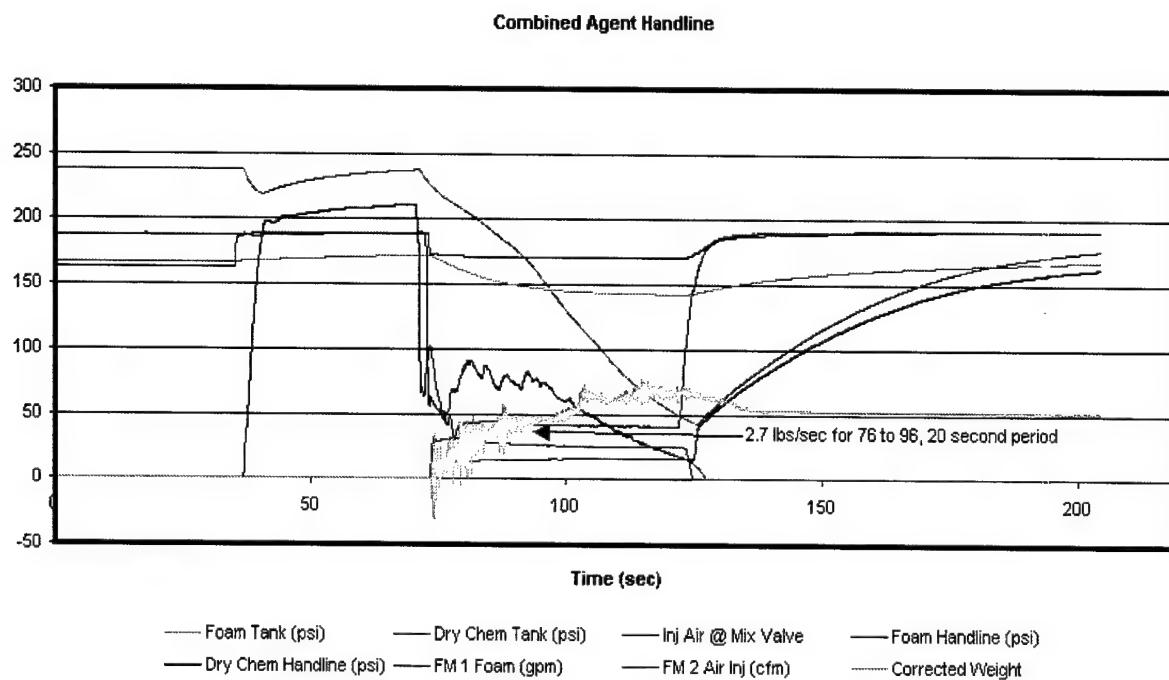
Figure 20. Foam Flow and Pressure Agent, Combined Agent Handline Disbursement.

Figure 20 shows the pressures and flow rates prior to the change of regulators. The initial dry chemical tank pressure was 237 psi and decreased to 219 psi when the handline was charged. The foam tank pressure increased to 167 psi before the handline was charged indicating a leak in the regulator. The foam flow rate was approximately 35 gpm and the dry chemical flow rate was 2.7 pps.

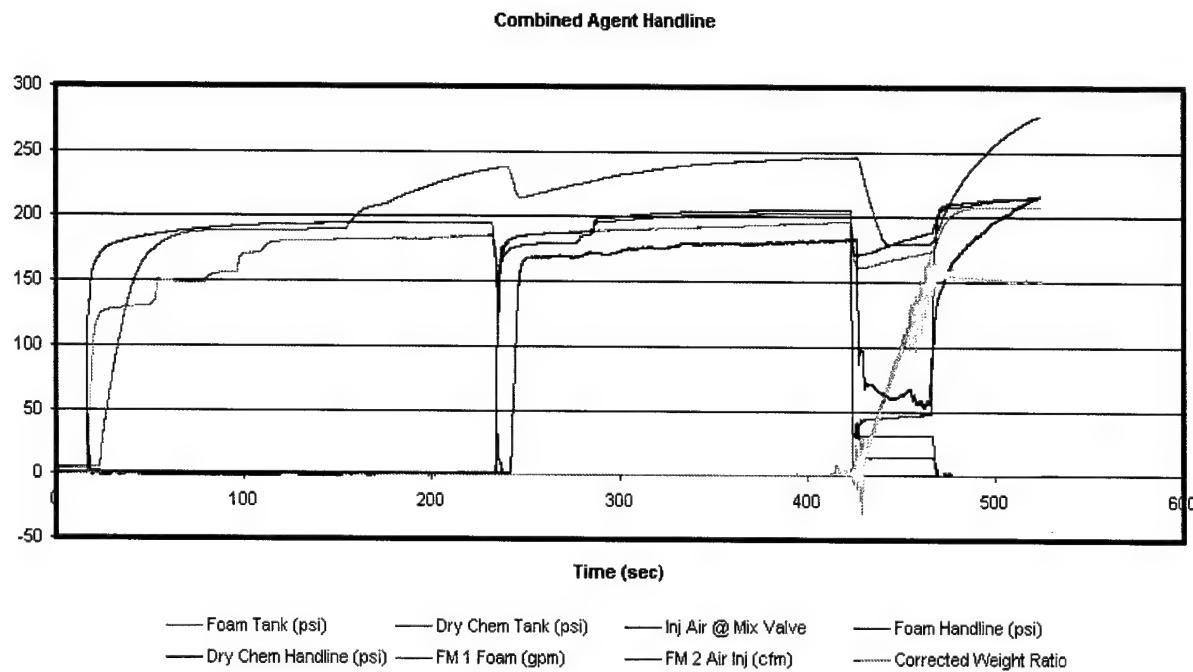
Figure 11. Foam Flow and Pressure Data, Combined Agent Handline Disbursement.

Figure 21 shows the pressures and flow rates after the change of regulators. The adjustments to the foam tank pressure and dry chemical pressure are seen on the data prior to the test start. After the test was completed, the foam tank pressure continued to build. The pressure in the foam tank increased to over 280 psi before the system was shut down manually. This not only indicated a problem with the regulator but also a problem with the pressure relief valve, which is suppose to activate at 250 psi. This is a serious safety concern and should be addressed in future systems. The amount of dry chemical flow rate averaged 4.2 pps.

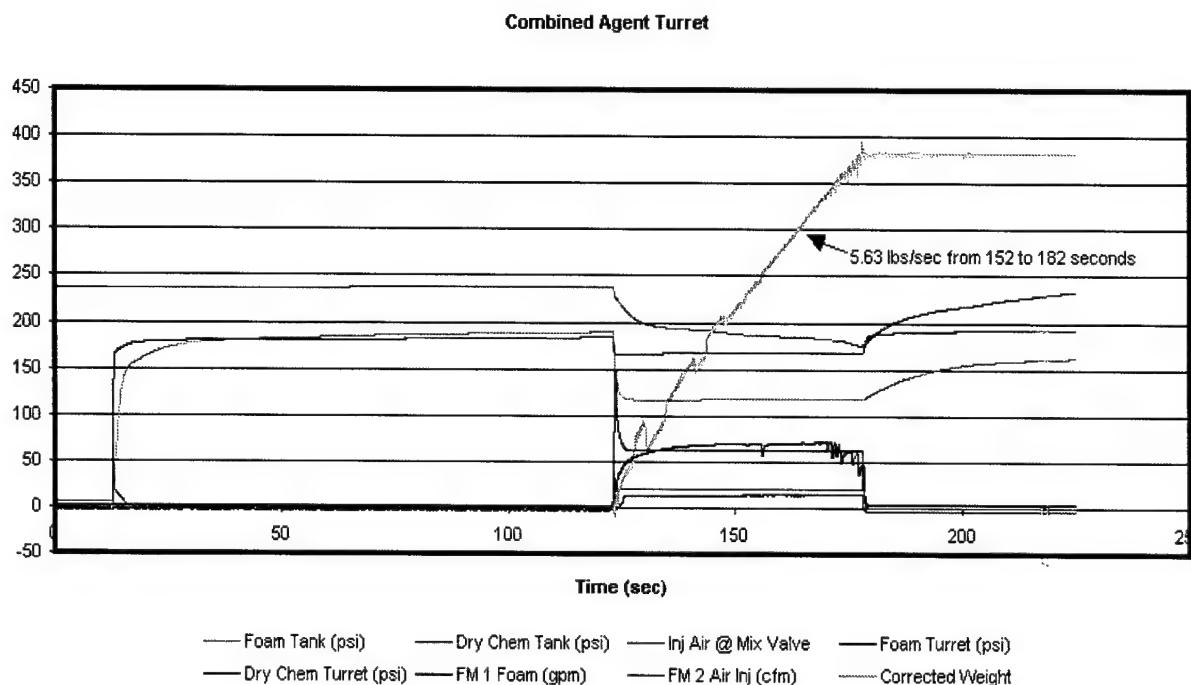
Figure 22. Foam Flow and Pressure Data, Combined Agent Turret.

Figure 22 shows the foam flow and pressure data for the combined agent test prior to the change of regulators. The foam flow averaged 55 gpm and the dry chemical flow averaged 5.63 pps. The foam tank pressure was maintained throughout the test at approximately 120 psi while the dry chemical tank pressure steadily decreased from 240 psi to 180 psi.

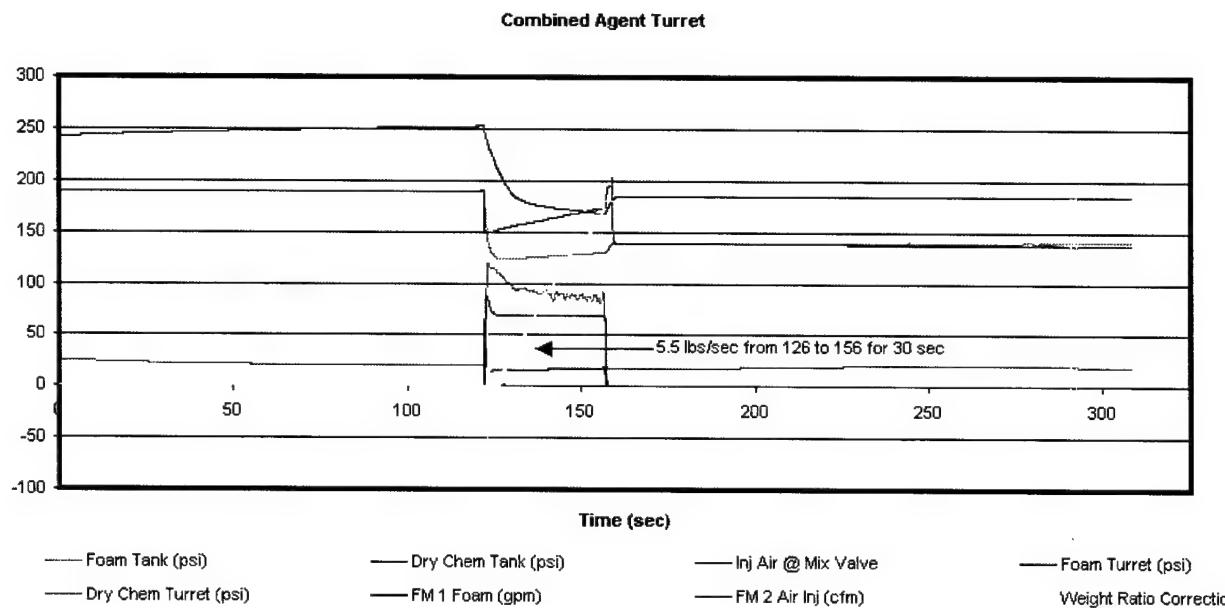
Figure 23. Foam Flow and Pressure Data, Combined Agent Disbursement.

Figure 23 shows the foam flow and pressure data after the regulators were changed. Foam flow rate decreased with the replacement regulators from 55 gpm to 20 gpm. The dry chemical flow rate stayed the same at 5.5 pps. The pressure on the dry chemical tank decreased from 250 psi to 170 psi during testing. The foam tank pressure increased slightly from 125 psi to 130 psi.
